**EXPERIMENTAL CULVERT PIPE, STH 80  
JUNEAU AND WOOD COUNTIES, WISCONSIN**

**FINAL REPORT**

**NOVEMBER 2003**

**FEDERAL EXPERIMENTAL PROJECT # WI 80-02,03,04**

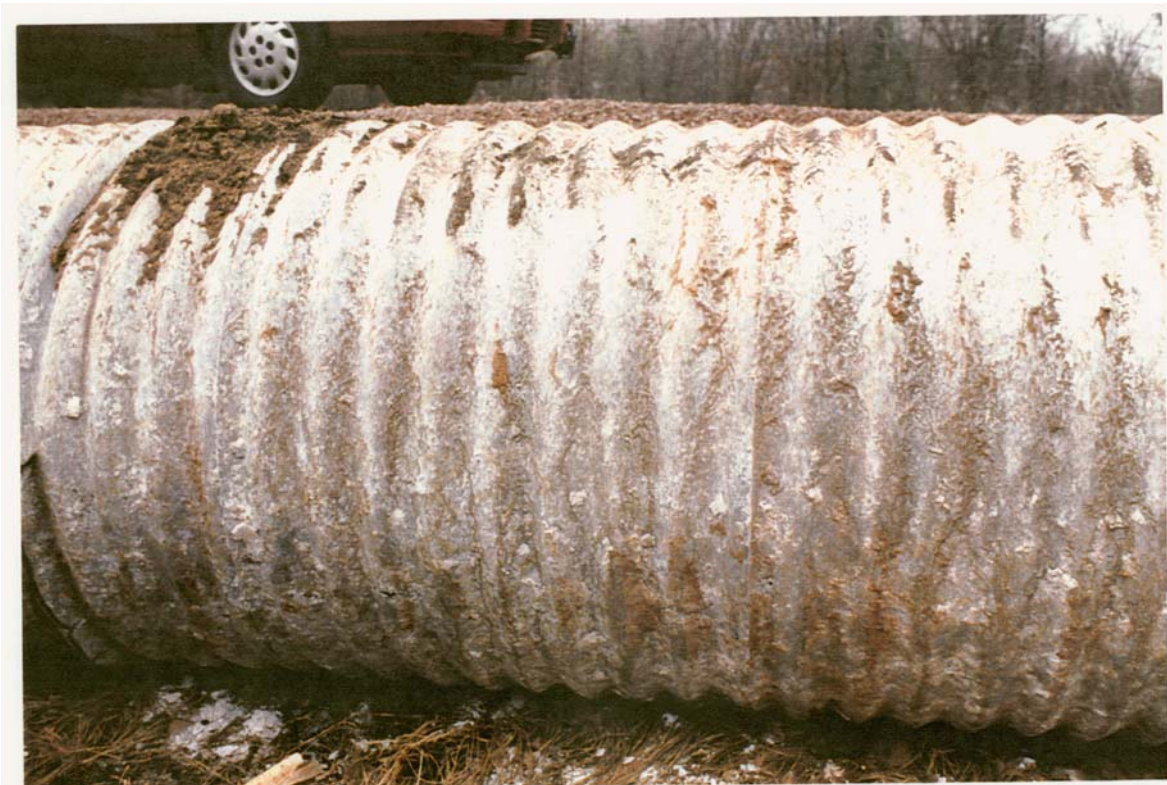
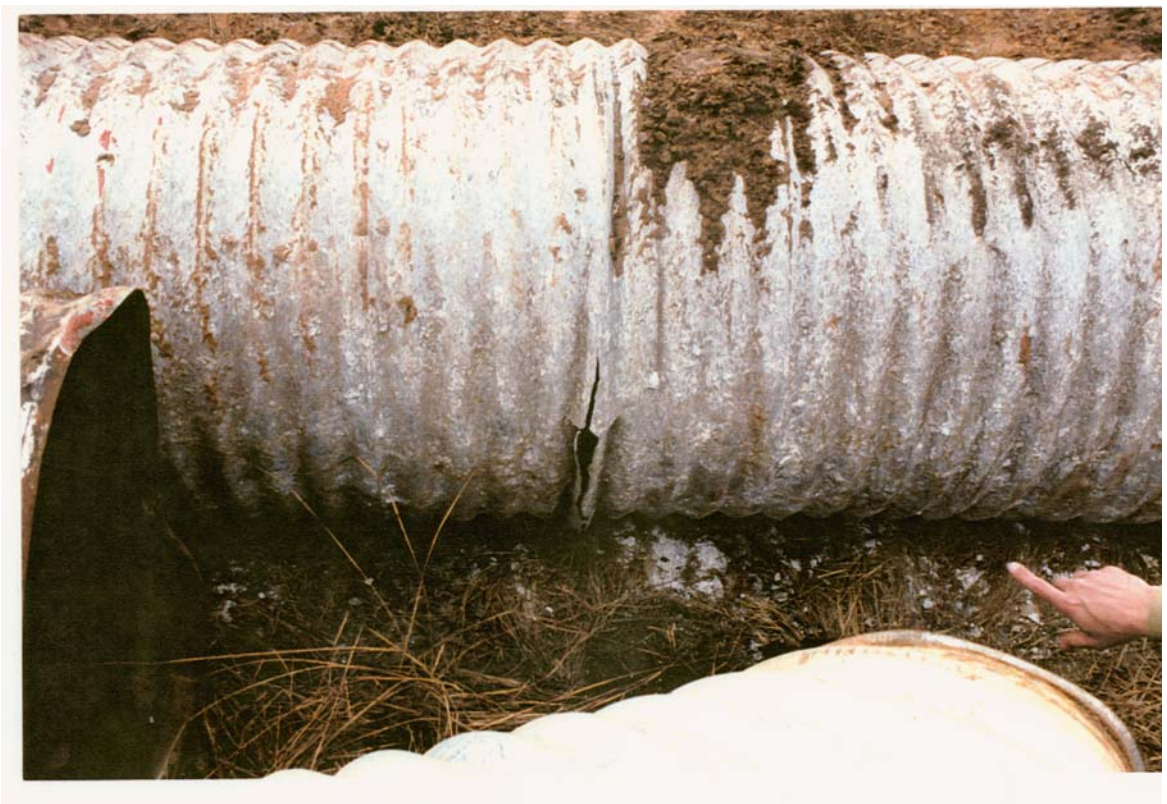
Station 976+40. Five small perforations, not visible at this scale, and apparent failure of aluminum pipe during removal. Also noted was white corrosion product and thinning of metal. 1995

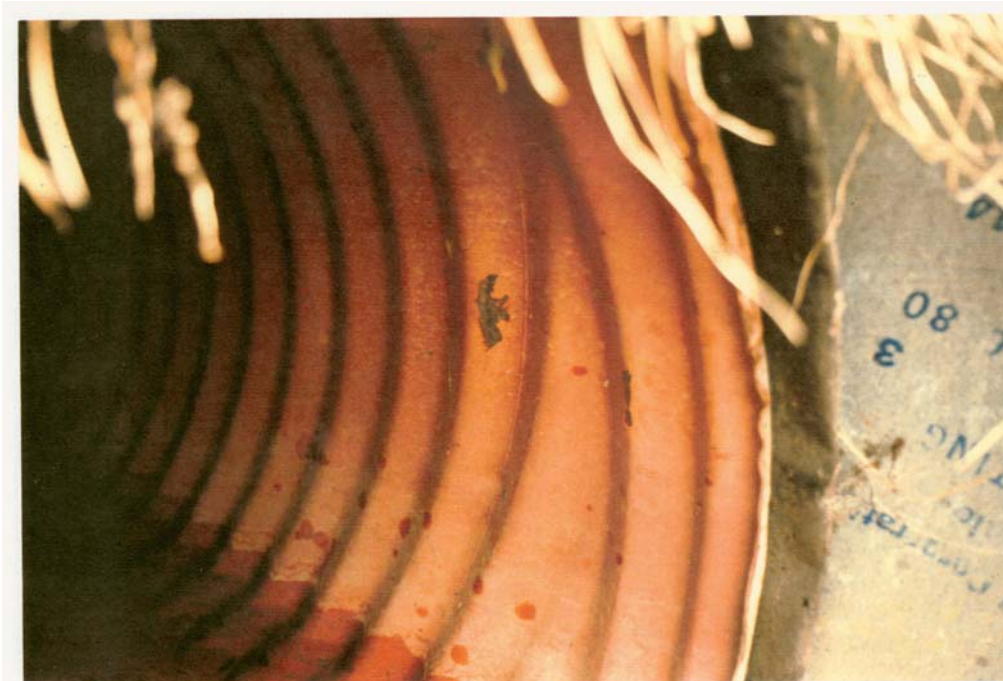
Station 1111+70. Loss of epoxy coating. West end. 1984

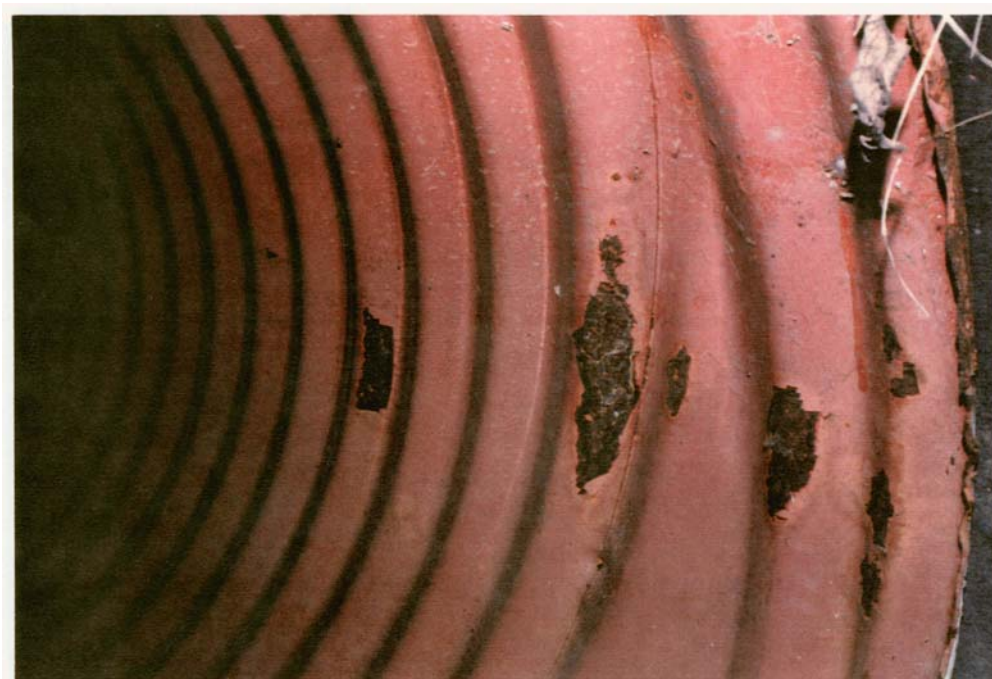
Station 1111+70. Enlarged area of coating loss. 1986

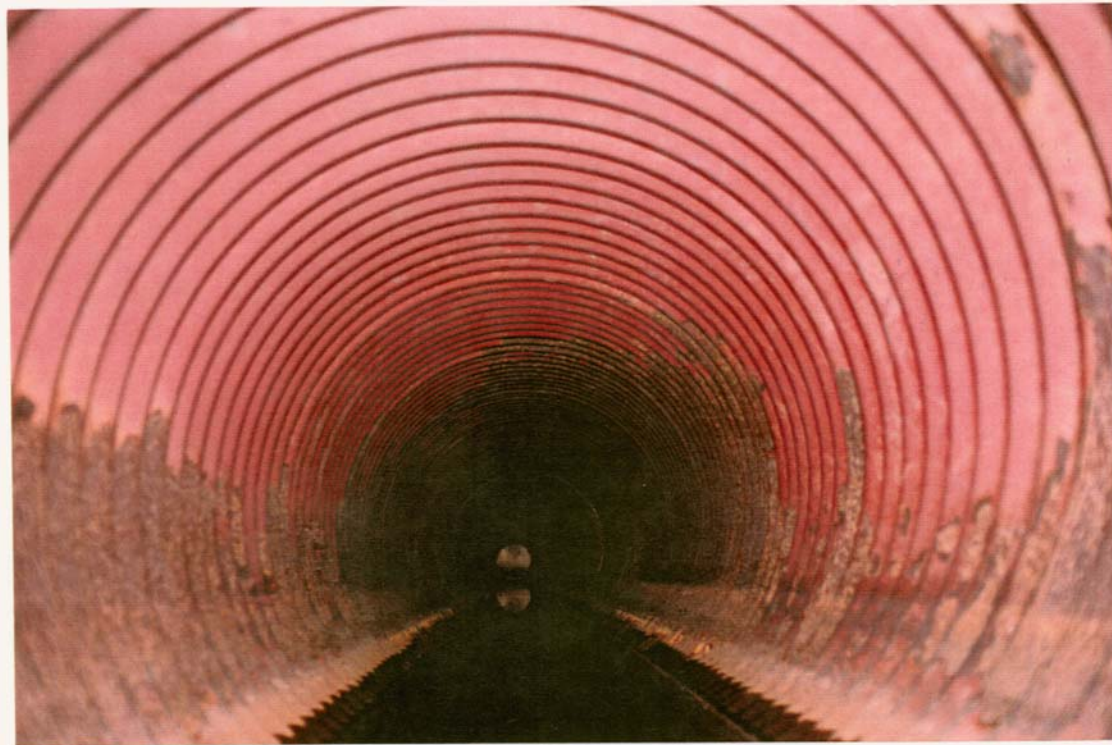
Station 1111+70. Epoxy bonded pipe with considerable loss of coating. 1994

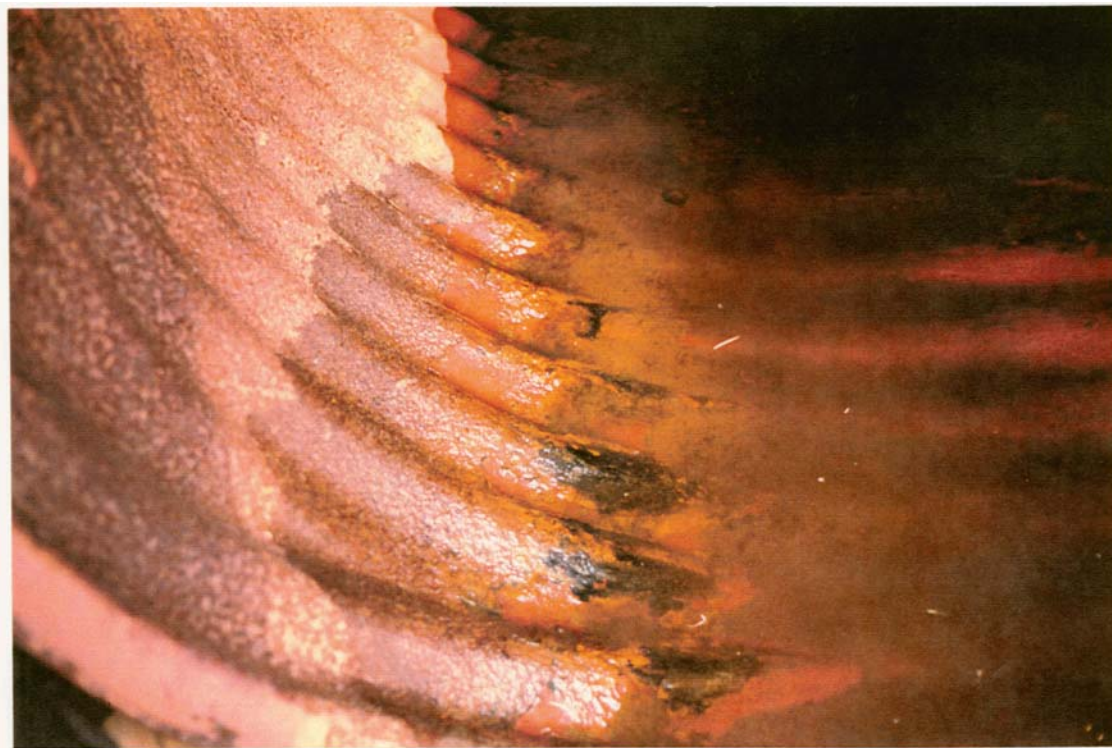
Station 1111+70. Epoxy bonded pipe with SRB nodules forming along edge of invert where steel is exposed. 1994

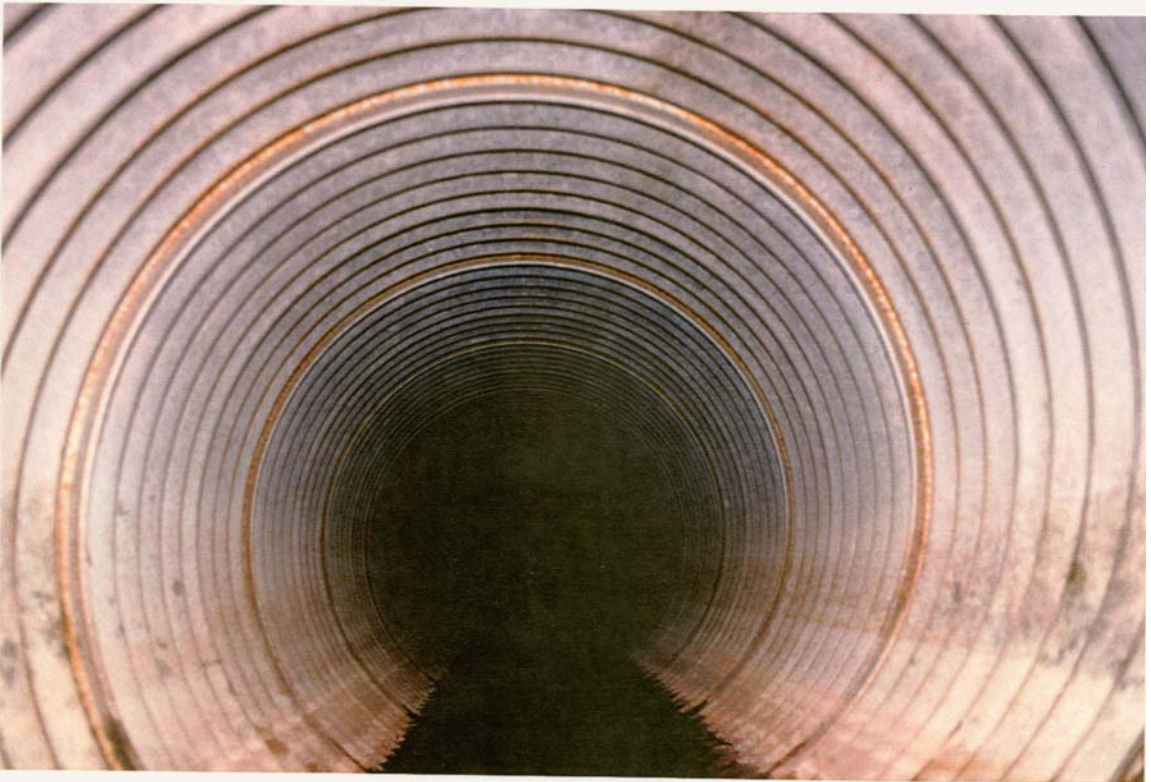
Station 1111+70. Aluminized steel pipe with staining of crimped seams. 1994

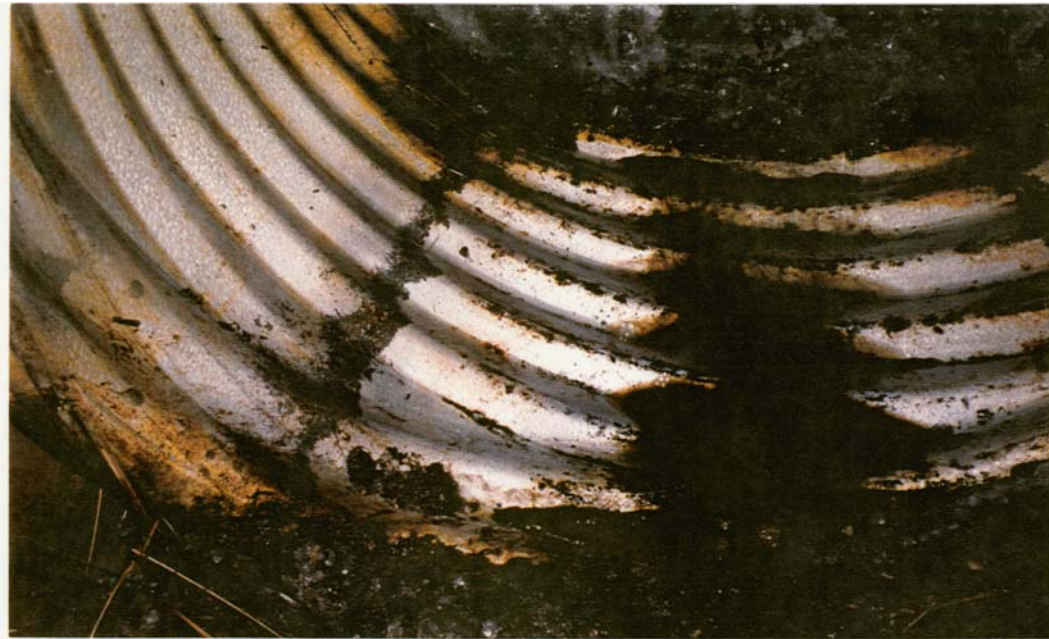
Station 1111+70. Loss of barrier coating along edge of organic accumulation and development of pits on tops of corrugations beneath organic material in invert of aluminized steel pipe. 1994

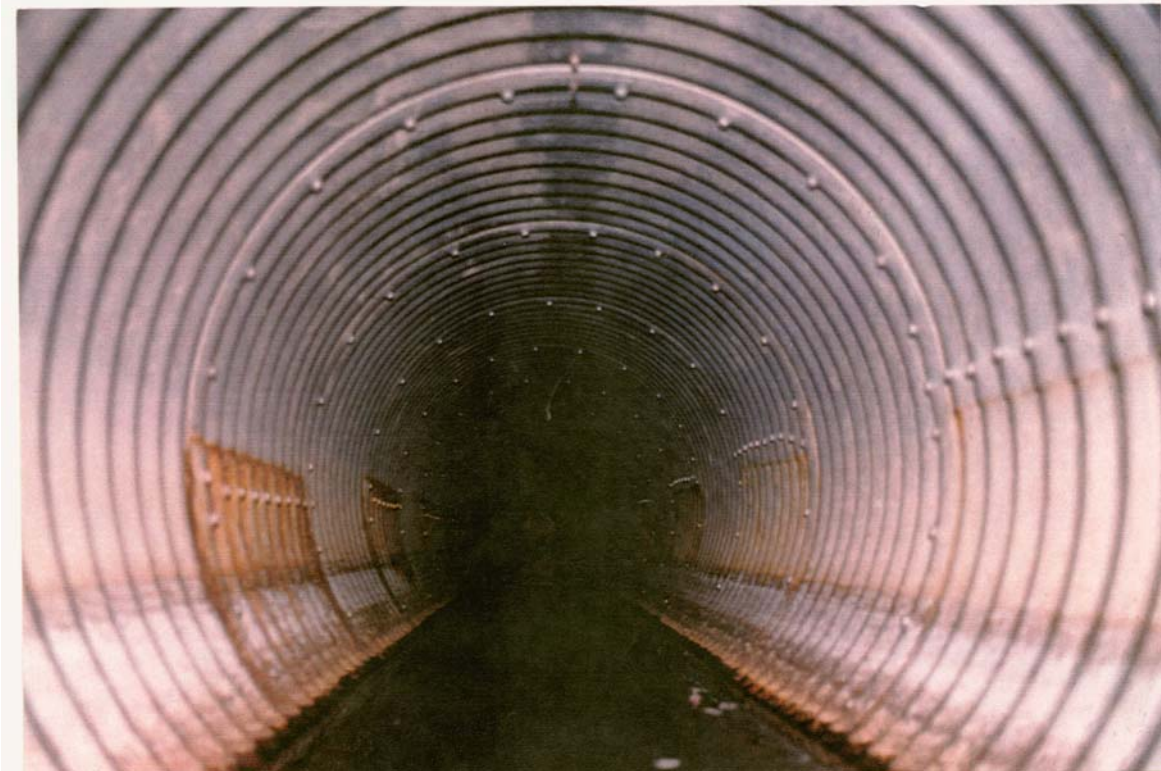
Station 1111+70. Aluminum pipe. No evidence of white precipitate at the joints in the roof of this pipe. 1994

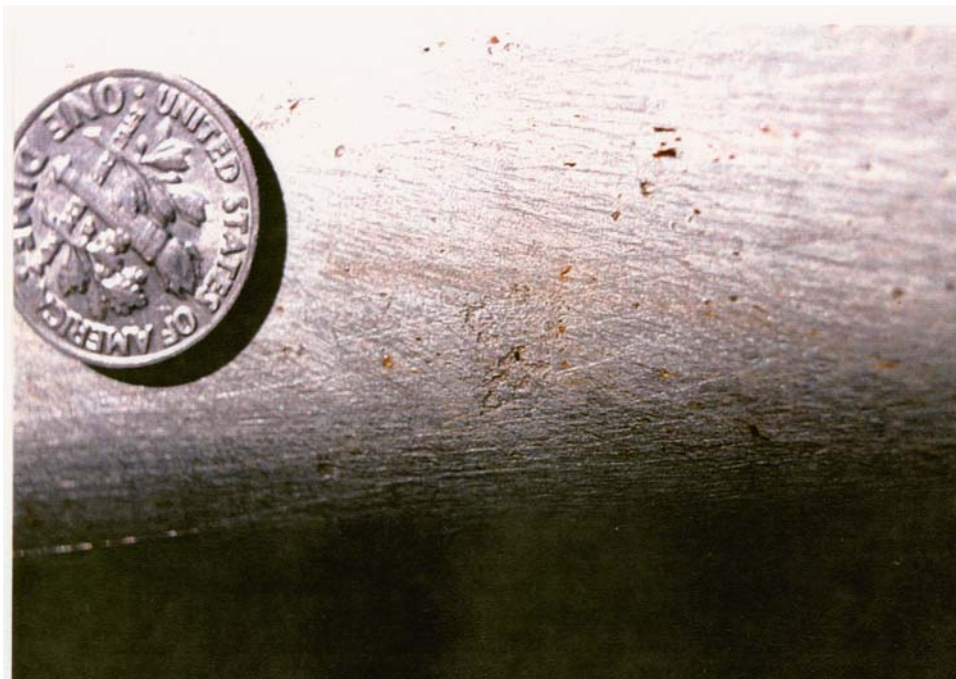
Station 1111+70. Aluminum pipe. Minor pitting of cladding in invert. 1994
